USAAMRDL-TR-76-11

ACOUSTIC EMISSION INVESTIGATION - HELICOPTER
ROTOR SYSTEM

BENDIX RESEARCH LABORATORIES
SOUTHFIELD, MICHIGAN

Final Report for Period April 1973 - December 1975

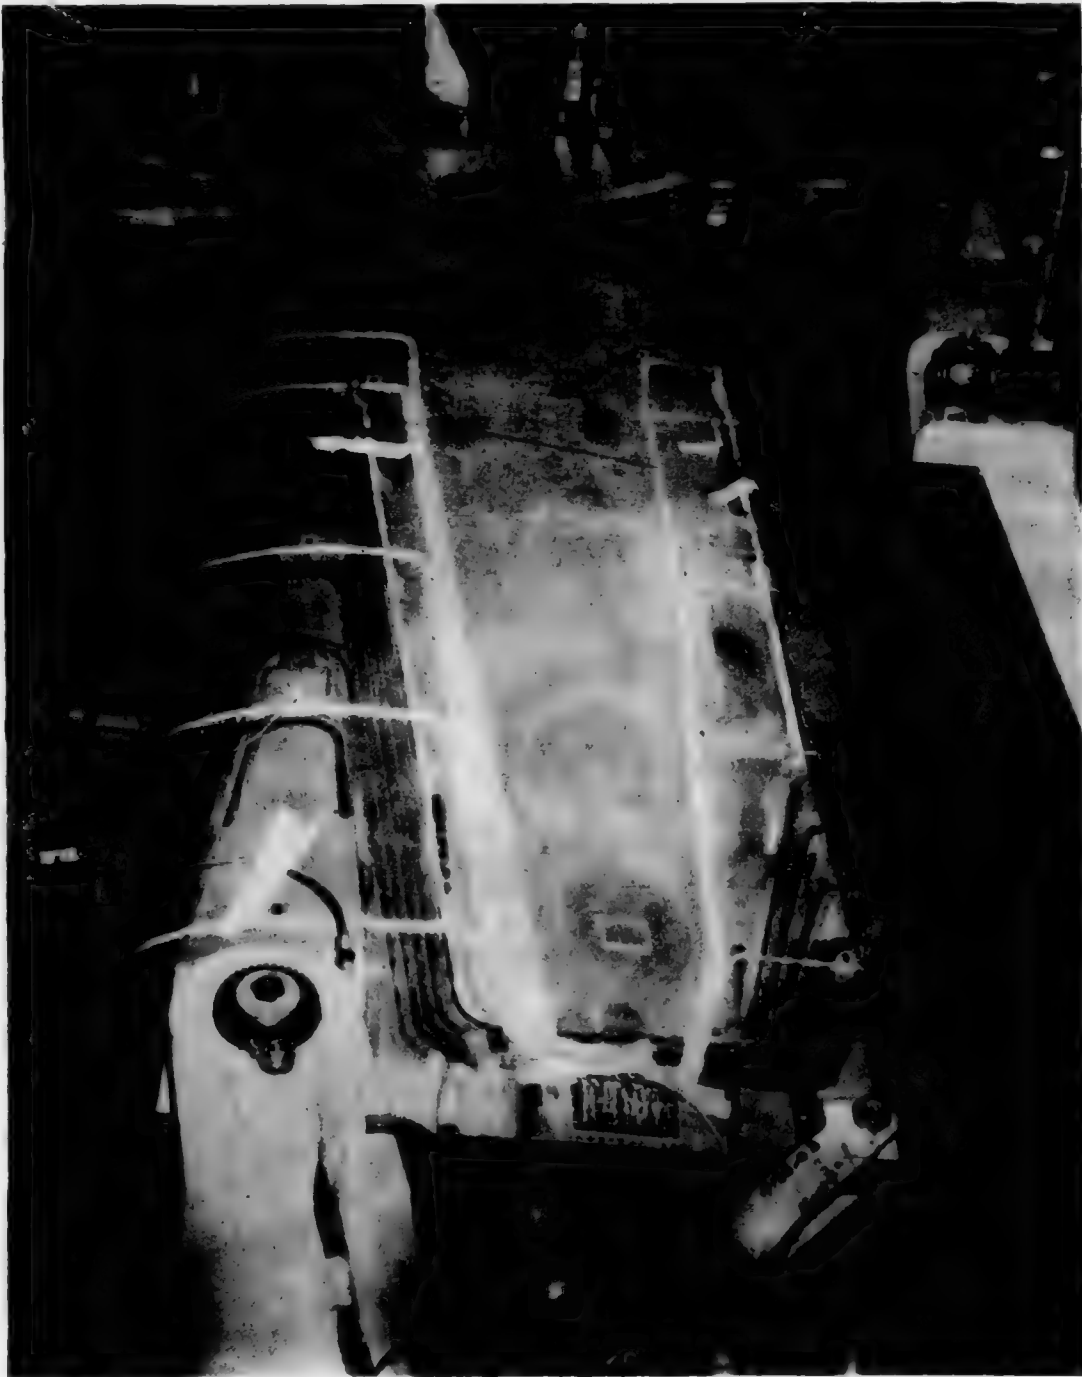
Figure 10 - Inboard blade section in place on fatigue machine.

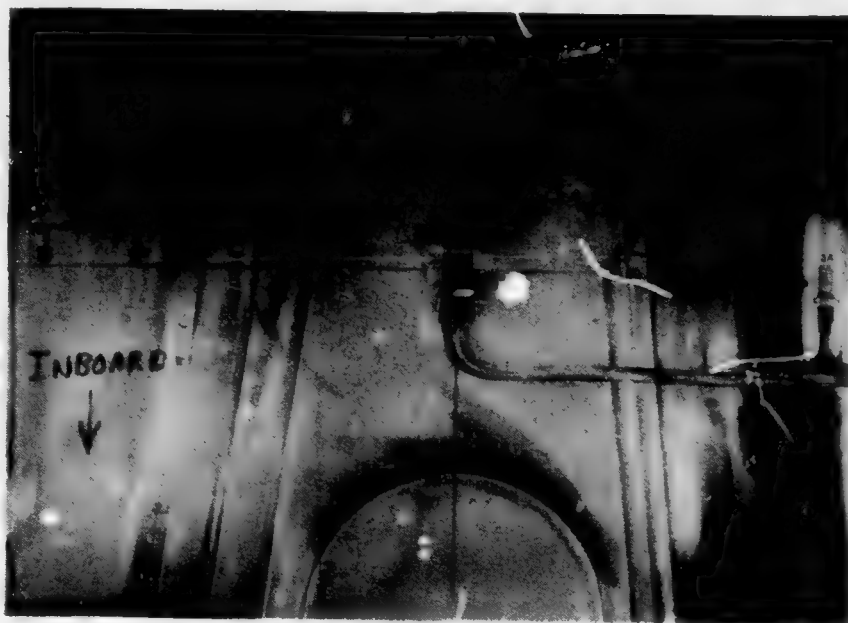
Figure 44 - Photograph showing location of failure in inboard blade section No. 3. Crack location outlined by black rectangle.
